Integrity Performance

Property Inspection Report

4530 Hwy 190 East, Livingston, TX 77351
Inspection prepared for: Steve Harvey
Date of Inspection: 3/27/2012 Time: 9:00
Age of Home: 26 Size: 2000 sqft
Weather: sunny
Brick veneer home with converted garage

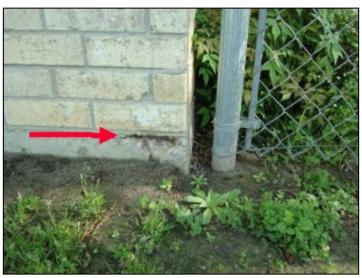
- Small cracking noticed in foundation
- NOTE: Slab-on-grade foundations are the most common type of foundation in the east Texas area for residential foundations, When supported by active or expansive soils, this type of foundation will deflect enough to cause minor cosmetic damage (usually drywall cracking, brick veneer cracking and floor tile cracking) and possible some minor function problems such as sticking doors and windows. Any owner of a building utilizing a slab on grade foundation should be prepared to accept a degree of cosmetic distress and minor function problems due to foundation movement.

Corner of Southeast slab has all pocket
$X \square X$	B. Grading & Drainage
	Comments: Past ponding was evident between sidewalk and front of house. Out structures and sheds are excluded from this report
$X \square \square X$	C. Roof Covering Materials
	Type(s) of Roof Covering: Fiberglass

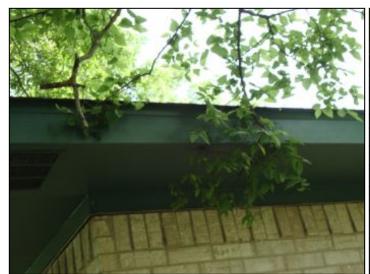
- Tree touching roof
- Flashing should be reset at time of roof instillation

Tree rubbing roof and facia board

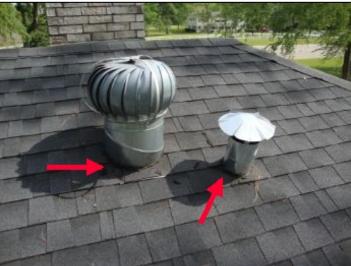
Flashing not reset when roof was replaced

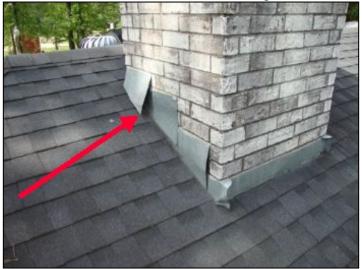
Counter flashing pulling away from chimney

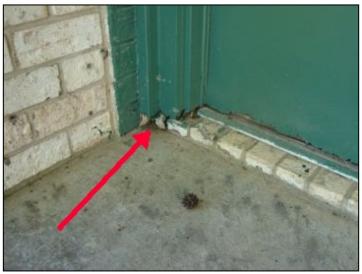
Wall Materials: Exterior walls are made of brick. Interior walls are made of Drywall Comments: Some rot on exterior facia board and door trim in need of repair

Water damage from rain splash on lower portion of door and molding

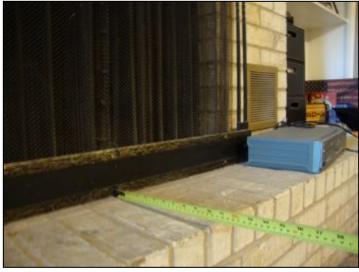
Comments: Hearth improper size

Minimum hearth extension is 16 inches

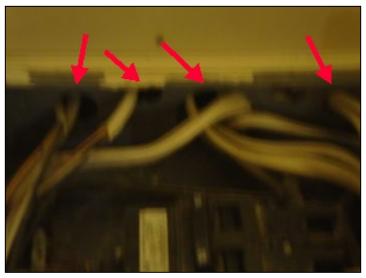
Comments: Main electrical Service panel box located in a closet
Missing bushings to protect wire

No bushings to protect wires

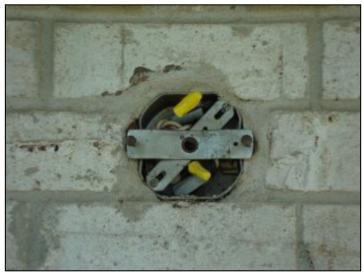
Type of Wiring: 200 Amp service panel Comments: Exposed electrical connections, There are white wires in the panel that should be labeled as hot wires, Breaker over amp for dryer circuit

Missing light fixture and exposed wires

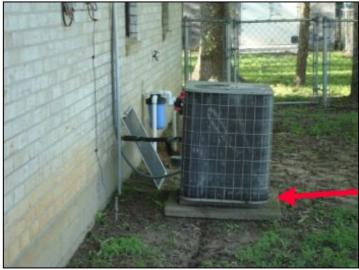
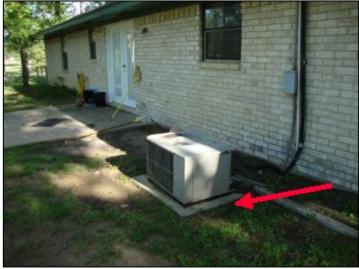
Comments: At the time of the inspection the A/C systems were performing there intended functions. At the time of the visual inspection it was observed that the exterior A/C condensing units on both systems were un level. A level unit will often run more efficient and have a longer service life

A/C unit should be made level

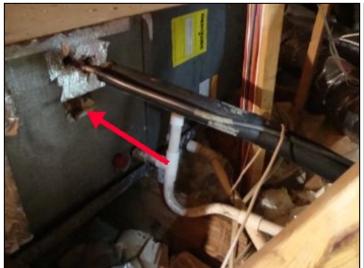
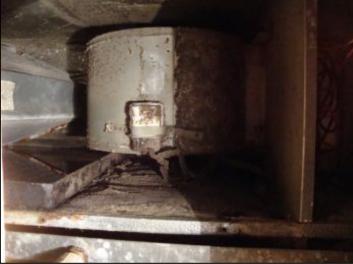
Air leaking on secondary A/C attic unit

Recommend A/C in attic be serviced and cleaned

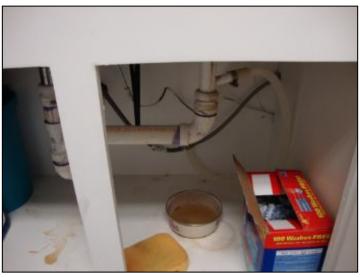
Comments: Leaking drain under kitchen sink. Septic tank was not inspected. Recommend having it Professionally inspected

Leak found under kitchen sink

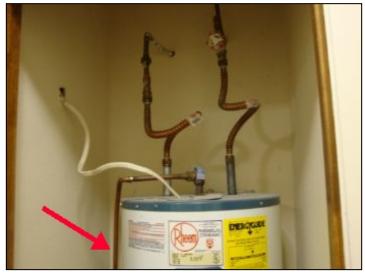
- T&P Relief valve has improper size drain tube and improper instillation
 Recommend over flow drain pan be installed

No drain pan and T&P relief valve drain pipe is installed improperly
